CROXLEY  
Rickmansworth  
GREAT BARN

feasibility  
report

February 2005

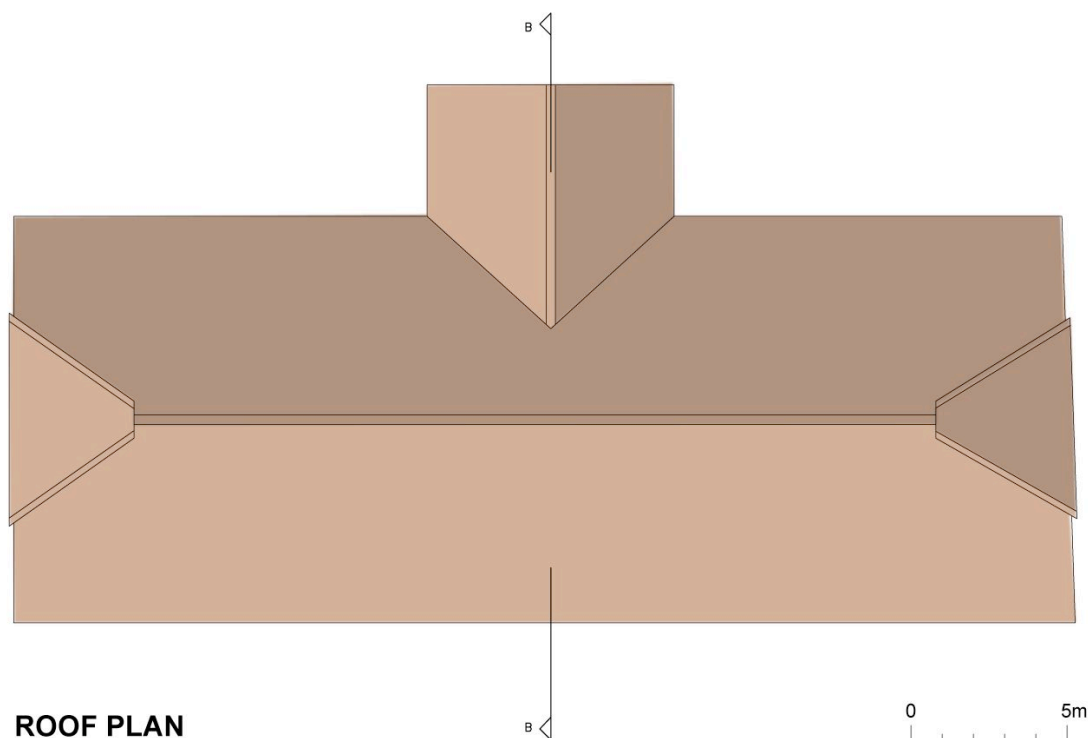
Fig. 4 Croxley Great Barn, Roof Plan

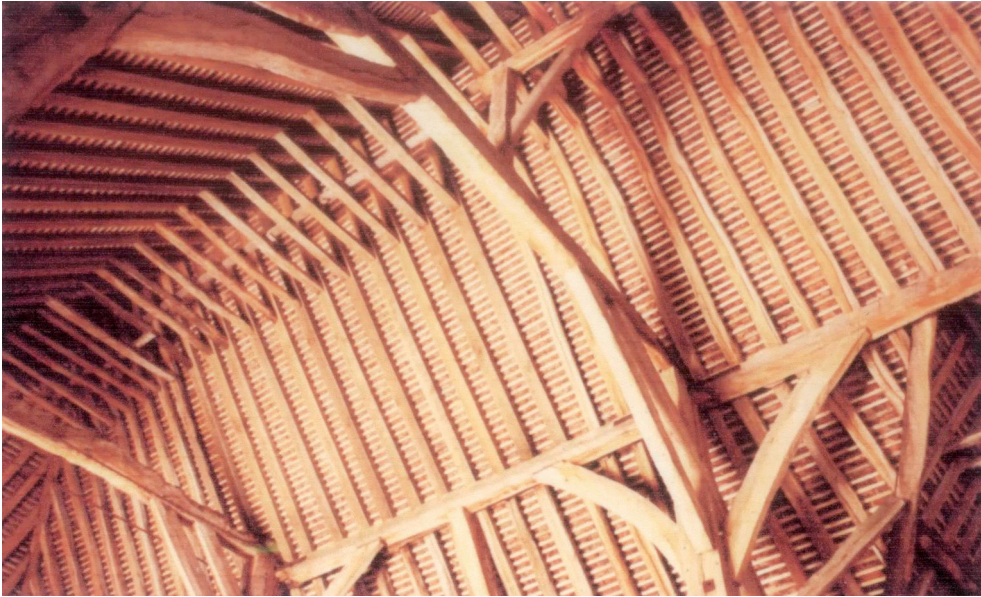
**Fig. 5 Croxley Great Barn, View of Roof Structure circa 1975**  
Photograph courtesy of Hertfordshire County Council

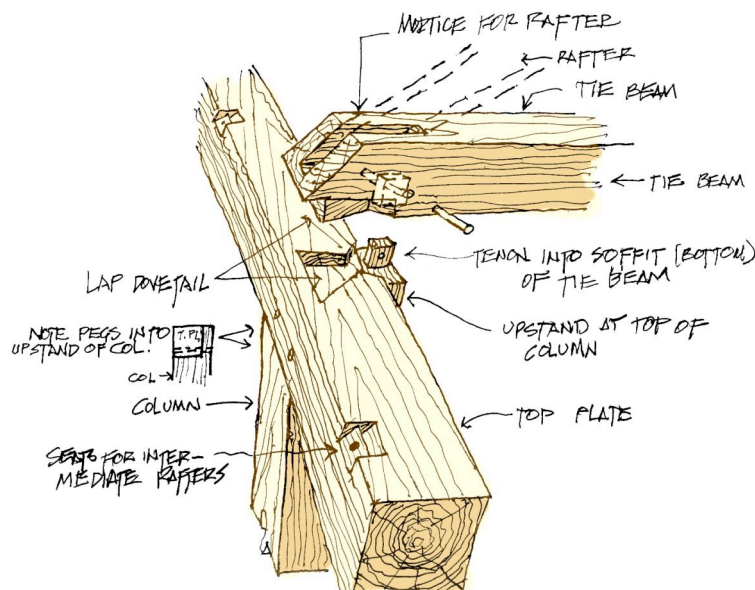
Fig. 9 Sketch Detail of arcade post/principal wall post showing traditional jointing

Tenoned to the shores and jointed to the wallplates are short squaresection ties. The right aisle tie and wall plate of the porch are one, and the supporting wall post is not jowled.

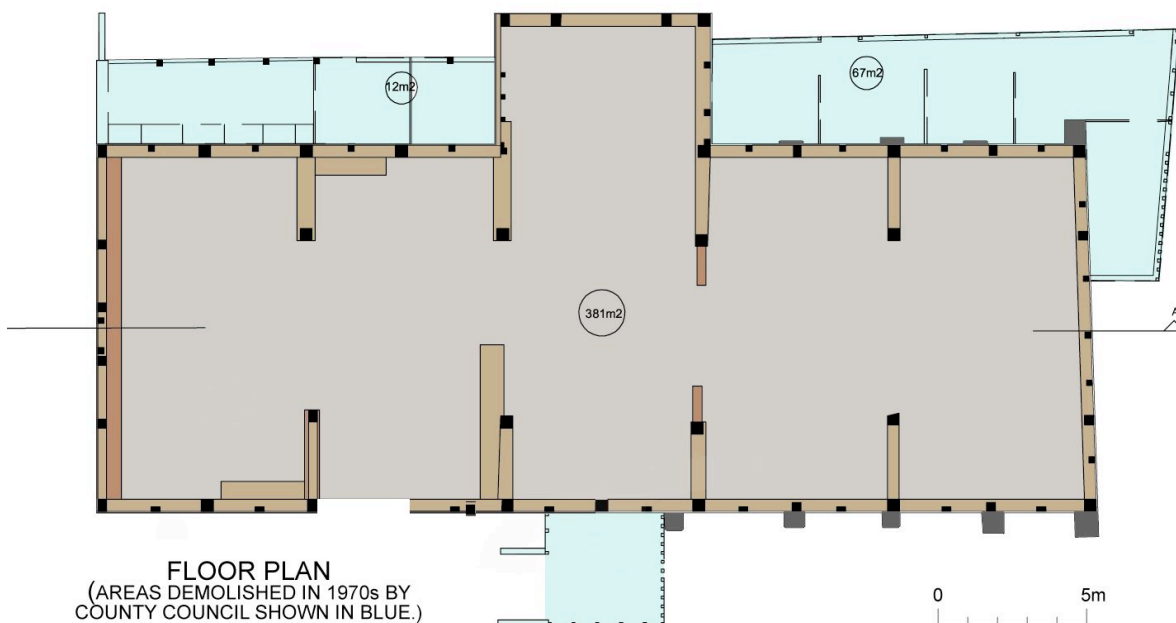
Fig. 10 Croxley Great Barn, Floor Plan

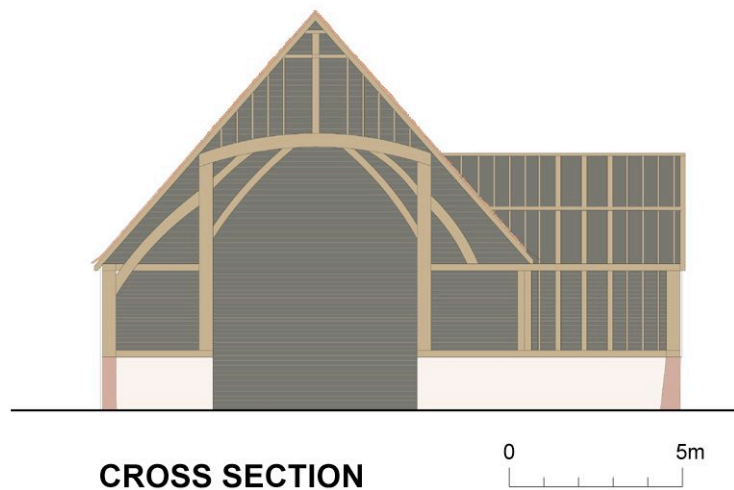
**Fig. 14 Cross section showing main structural frame and bracing**

*Probably built 1396-1401 for Abbey of St Albans during abbacy of John Moote, restored in 1975. Timber frame. Flint, clunch and brick base walls. Weatherboarded. Tiled roof. 5 bays with nave and aisles, 2 bay entrance porch. 101ft by 38<sup>1/2</sup>ft. Central gabled entrance porch to E with double doors. C17 brick buttresses to base which has a low hipped roof with gablets. Interior: hoggin floor, lime washed, 5ft high flint walls with clunch quoins and coping separate each bay in aisles. 2 central crown post trusses with outer collar and tie beam trusses. Arched braces from jowled arcade posts to tie beams and arcade plates. Crown posts braced to crown plate. Passing braces from wall posts to tie beams with lap joints to aisle ties and arcade posts. Intermediate braces from wall posts to arcade plates. Arched braces in end walls. Angled queen struts clasp purlins in entrance porch.*

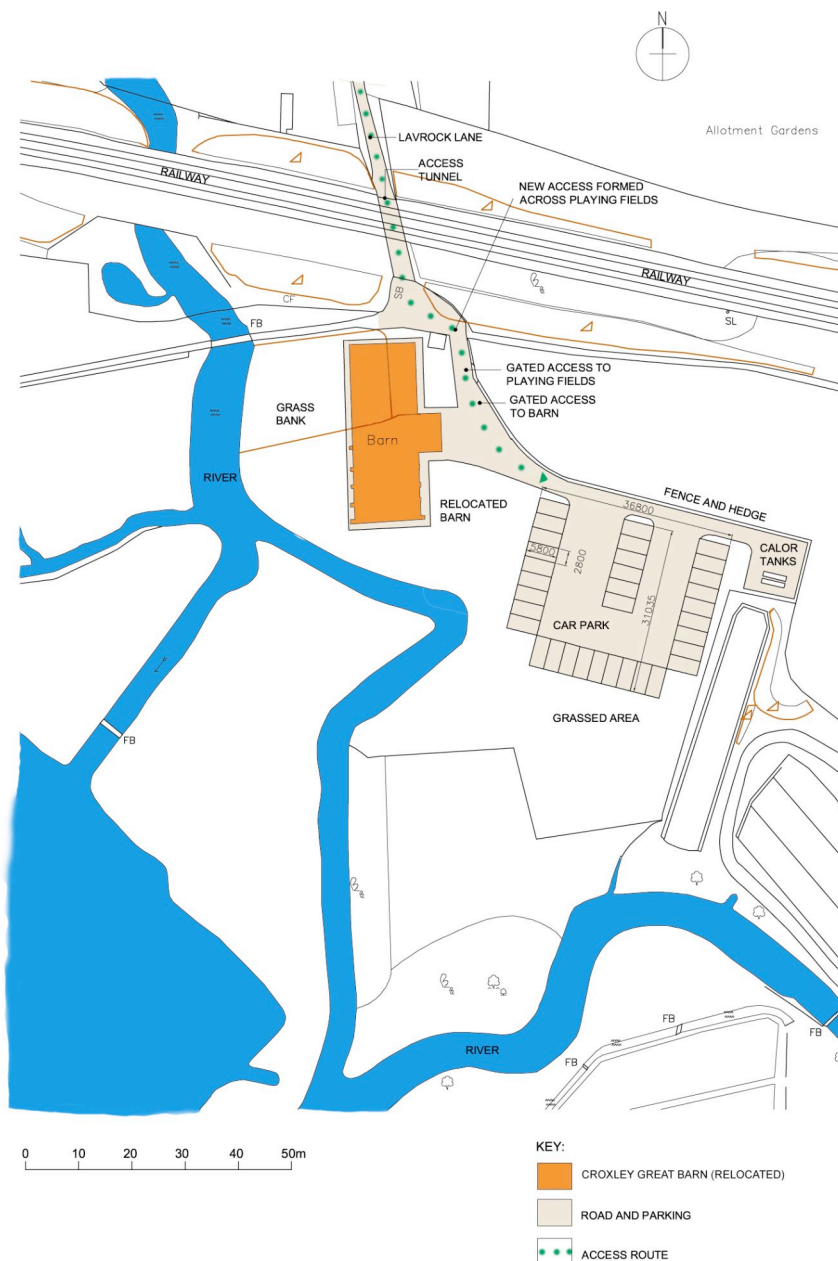
Fig. 23 Plan showing access to Croxley Great Barn – Option D (not to scale)

The suggestion is made on the basis of 'brainstorming' and it is understood that Green Belt, Planning and English Heritage concerns may render this option unlikely. None the less, it is felt a valuable exercise to evaluate likely costs and the physical potential.

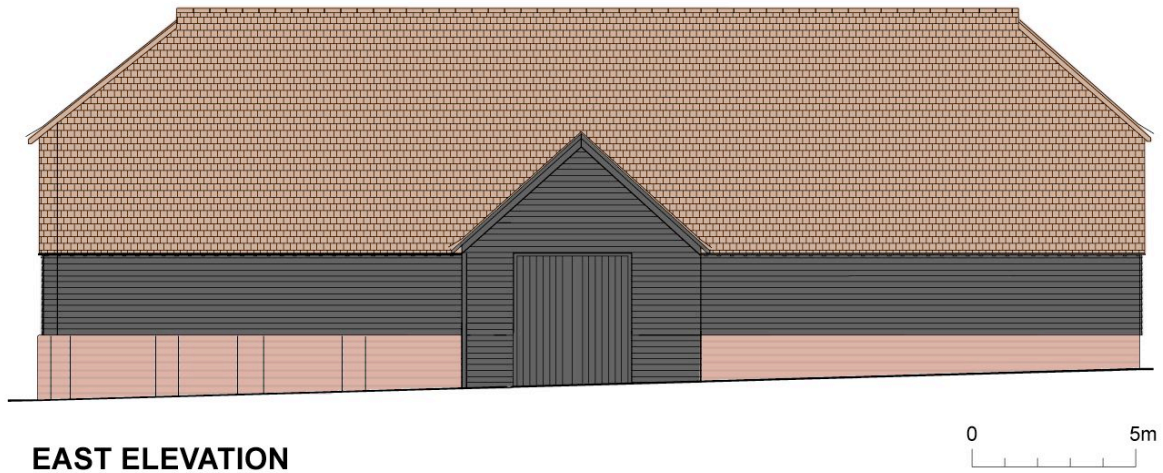
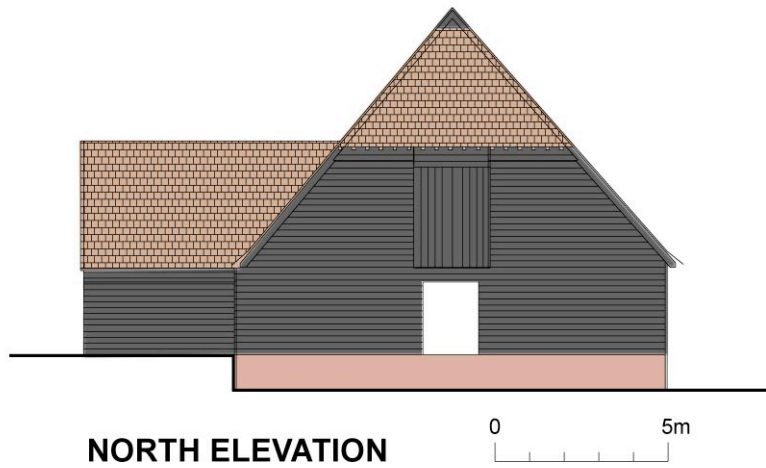
**Fig. 29 Croxley Great Barn, East and North Elevations**

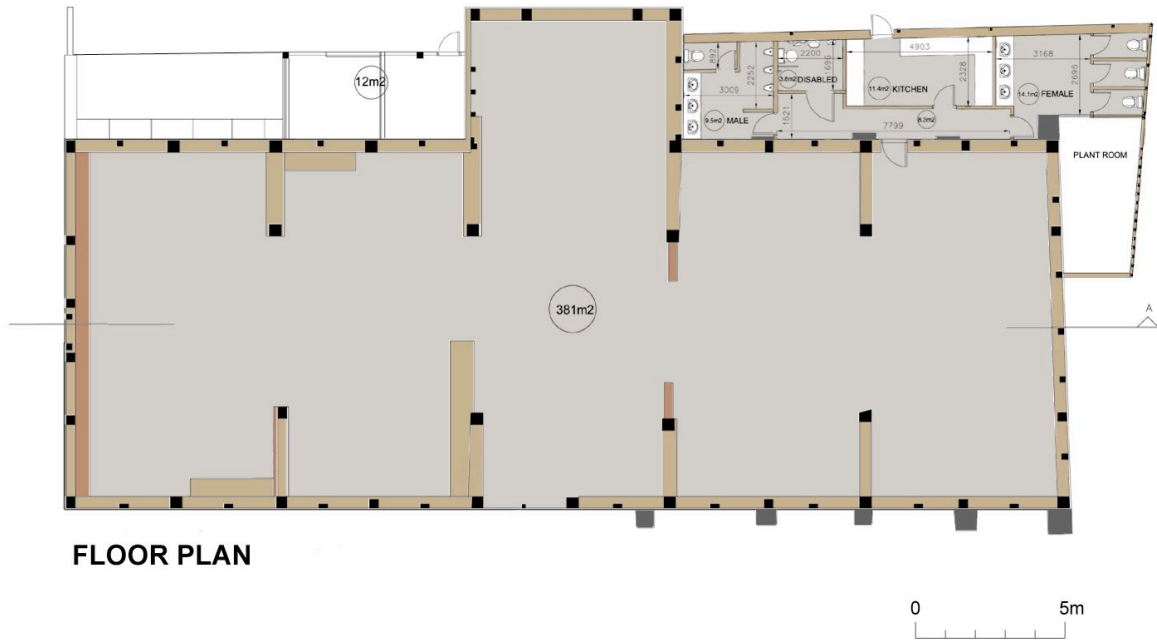
Fig. 30 Croxley Great Barn, Proposed Plan Illustrating Reconstructed 'Upstand' Structures to East Elevation

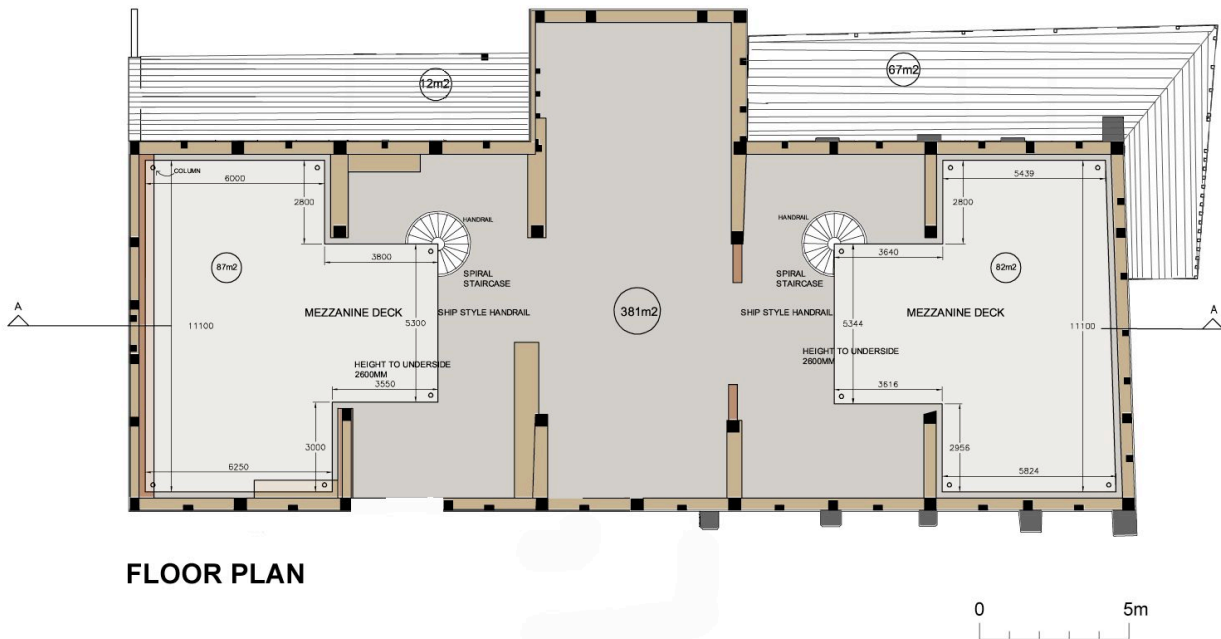
Fig. 31 Croxley Great Barn, Proposed Plan including Mezzanine floors

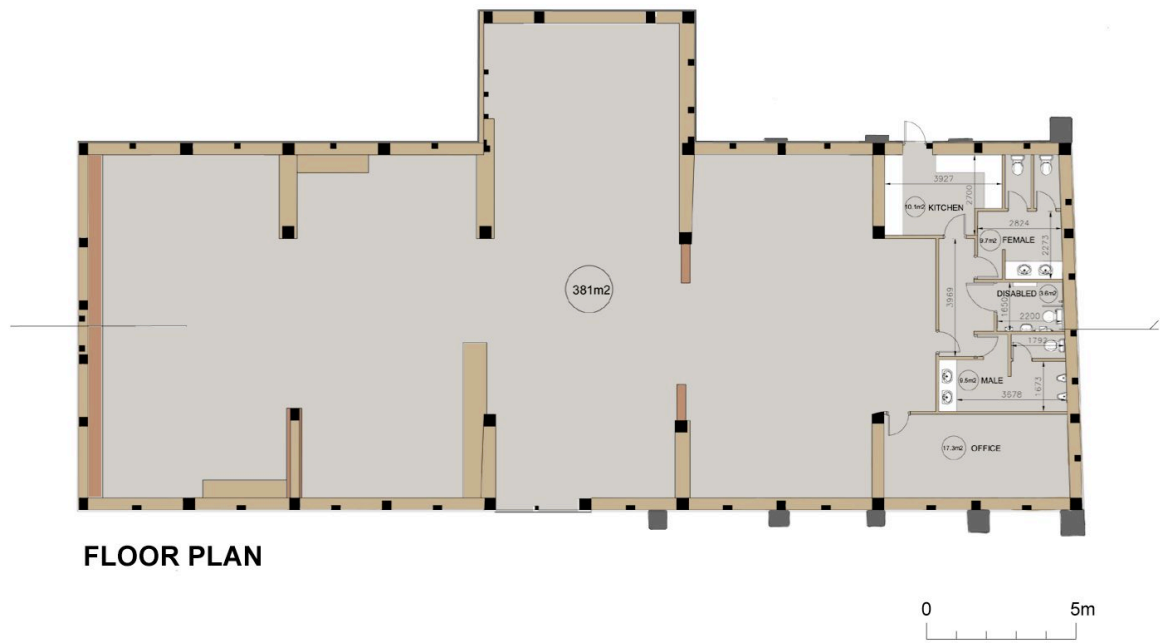
Fig. 32 Croxley Great Barn, Proposed Option including Internal WC's at South End of Building

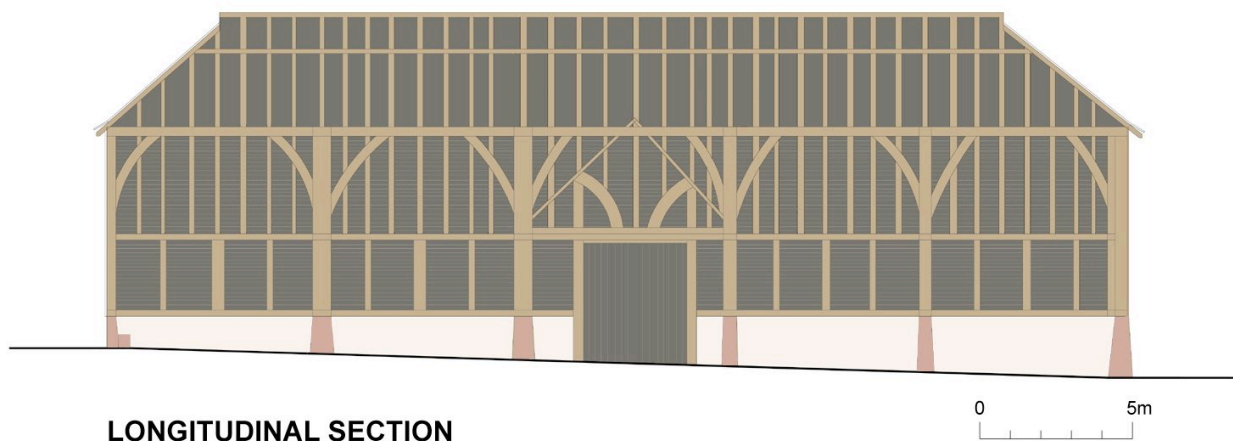
**LONGITUDINAL SECTION**

**Fig. 33 Croxley Great Barn, Longitudinal Section**

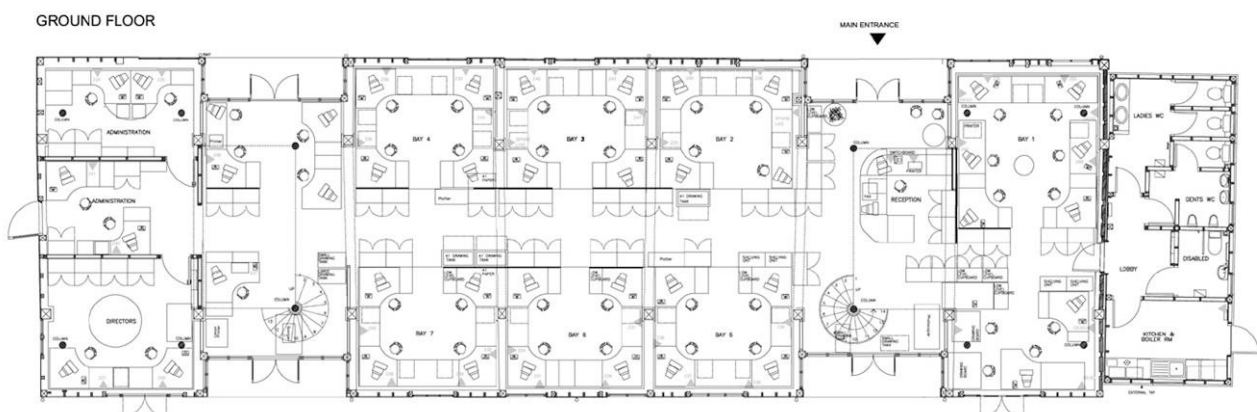
Fig. 48 The Tithe Barn, Harpendenbury Farm, Redbourn – Floor Plan

The floor area of the barn is approx. 343m<sup>2</sup> on the ground floor (inc. lean-to) and 150m<sup>2</sup> on the mezzanine decks. (500m<sup>2</sup> overall)
